ALL SAINTS ANeW

Recorded Issues inclusive of non-compliances and defects
associated with the Refurbishment Project for

All Saints ANeW Anglican Church building

Building Works Renovations Defects as at 6th March 2026

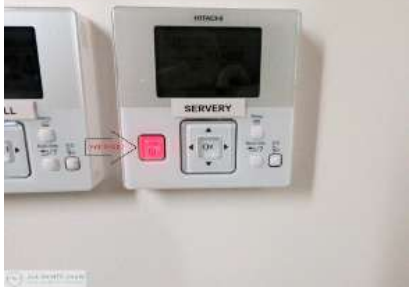
ref	Trade	Description	Image	Status
A1	A/C	Servery failed split A/C (controller image)

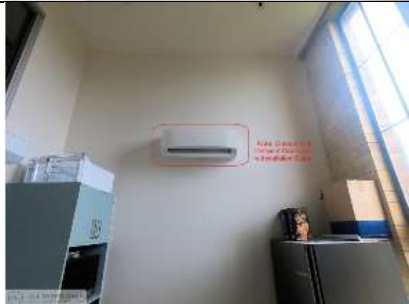
⊗
A2	A/C	Servery failed split A/C (indoor unit image)

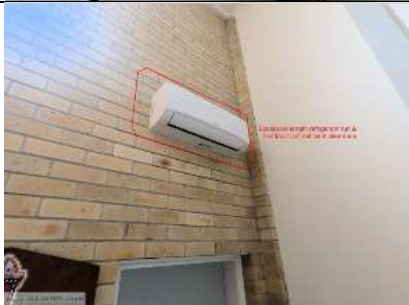
⊗
A3	A/C	Vestry spit/AC too long refriger run

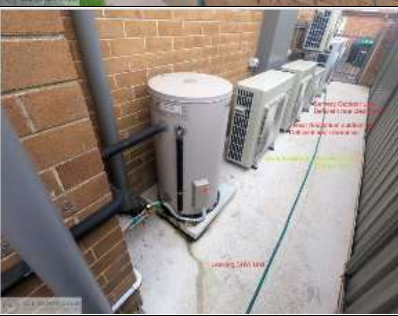
info
A6	A/C	External SE passage outdoor unit issues Note leaking Domestic Hot water unit

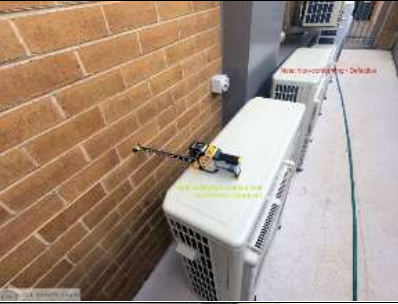
⊗
A7	A/C	External SE passage outdoor unit issues Closest unit ok, but next unit too close (82mm when Hitachi state minimum 100mm)

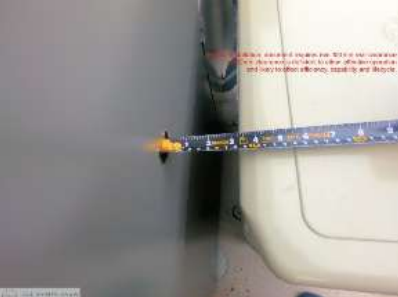
⊗
A8	A/C	Unit too close 82mm where Hitachi require minimum 100 clearance to allow effective air heat transfer / obstructed - relocate

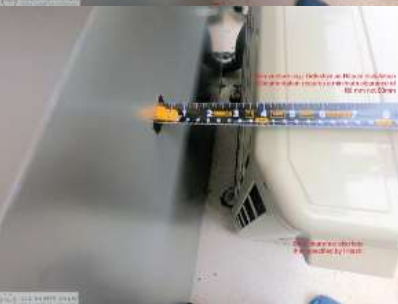
⊗
A9	A/C	Unit too close 93mm where Hitachi require minimum 100 clearance to allow effective air heat transfer / obstructed - relocate

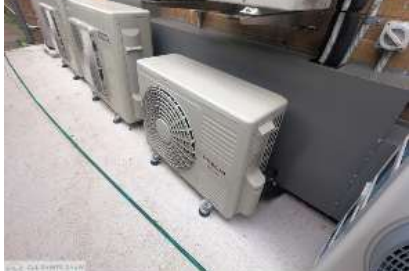
info
AG	A/C	Vestry outdoor unit (may be vestry) to close

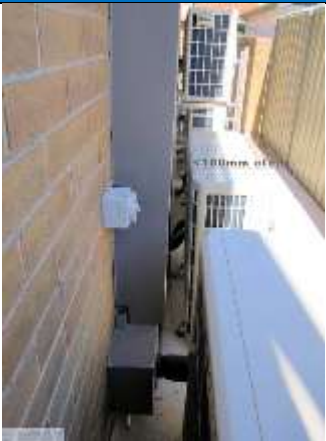
ref	Trade	Description	Image	Status
AH	A/C	Deficient clearance <100mm

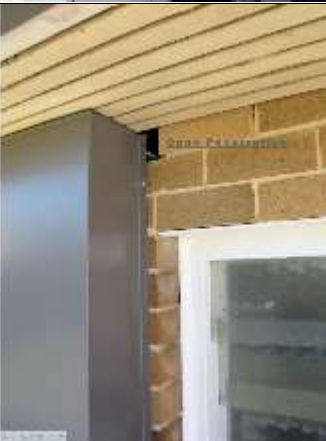
☑
AK	A/C	Penetration unsealed (don't use foam)

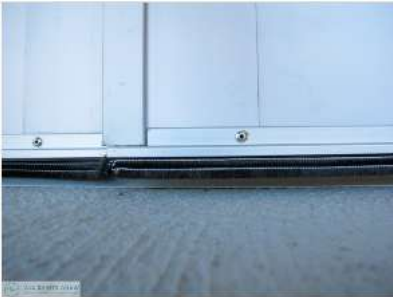
ref	Trade	Description	Image	Status
BC	Builder	Threshold

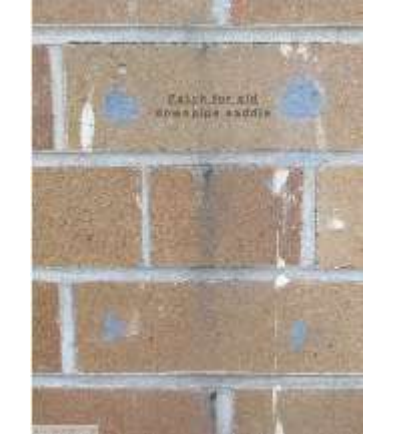
⊗
BE	Builder	Inept patch of old downpipe saddle holes

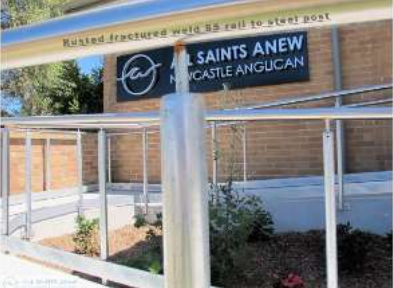
⊗
BF	Builder	Entrance rail weld fractured Sign without appropriate right border

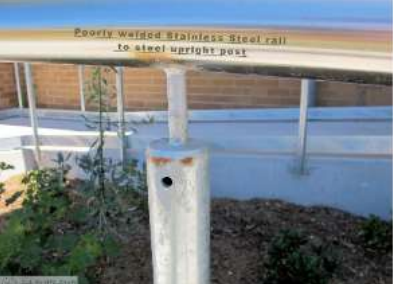
⊗
BG	Builder	Entrance ramp gal steel post & SS rail

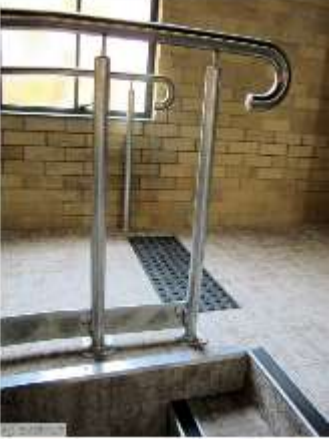
⊗
BQ	Builder	Handrail ramp to stage

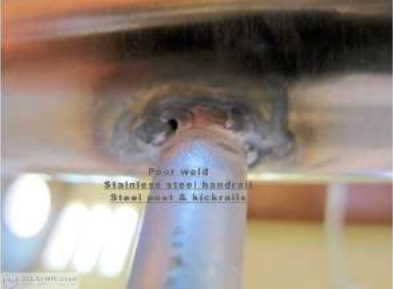
⊗
BR	Builder	Handrail ramp to stage – poor weld

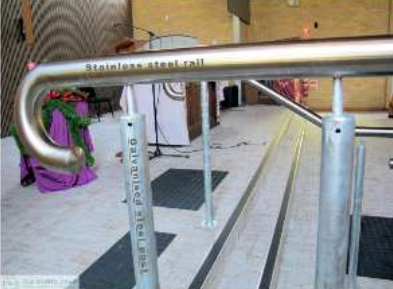
⊗
BS	Builder	Handrail ramp to stage Galsteel post & kickplate welded to Stainless steel rail

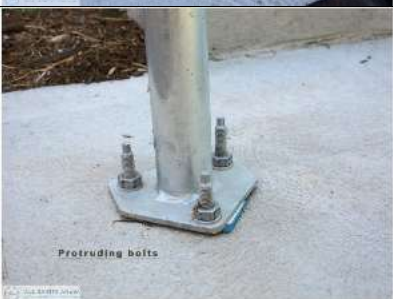
⊗
BV	Builder	Proud bolts on exterior post

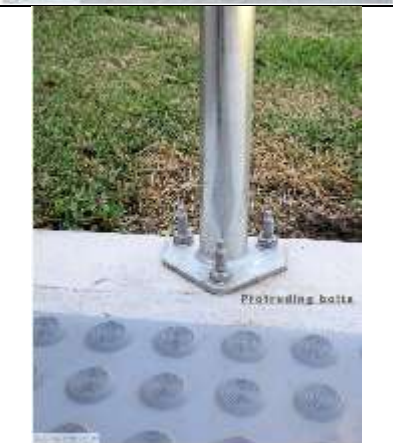
⊗
BW	Builder	Proud bolts on exterior post

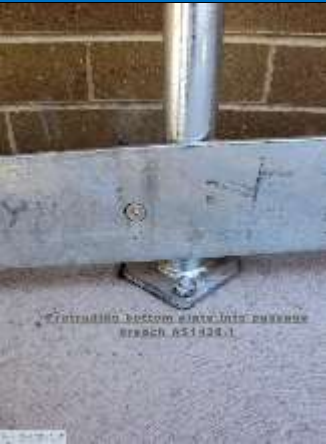
ref	Trade	Description	Image	Status
BX	Builder	Plate extends past kickplate into ramp – non-conforming to AS1428

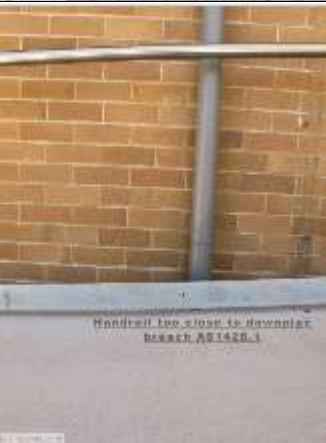
⊗
BY	Builder	Rail handrail deficient clearance when passing downpipe.

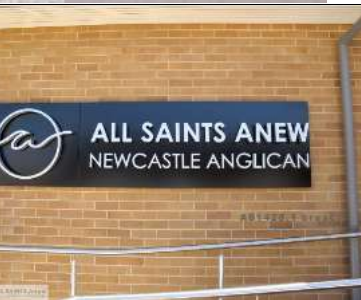
⊗
BZ1	Builder	Ramp rail entry handrail deficient clearance when passing downpipe Non conforming to AS1428 and too great a span without post or wall bracket Sign without appropriate right hand border

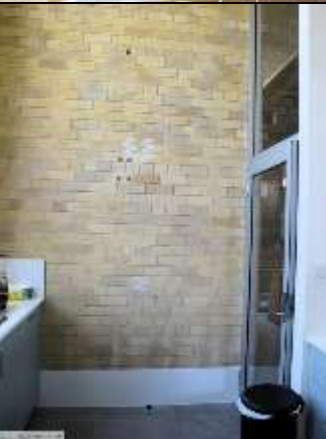
⊗
BZ2	Builder	Wall finish (servery)

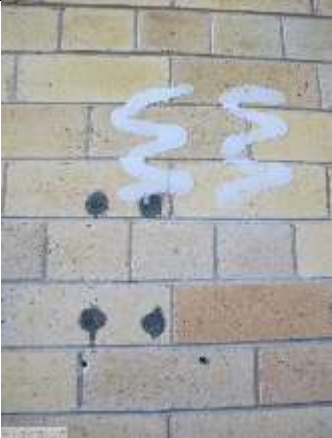
ref	Trade	Description	Image	Status
BZ3	Builder	Wall finish (servery)

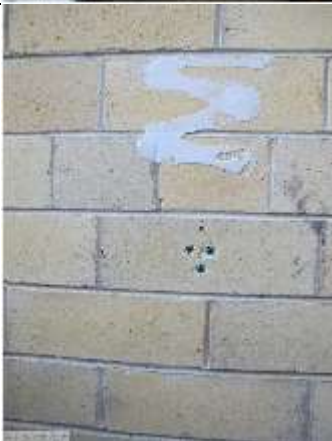
info
BZ5	Builder	Wall finish

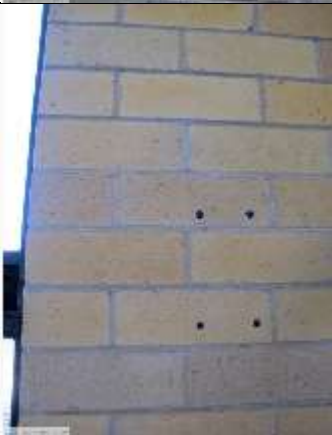
⊗
BZ6	Builder	Wall finish

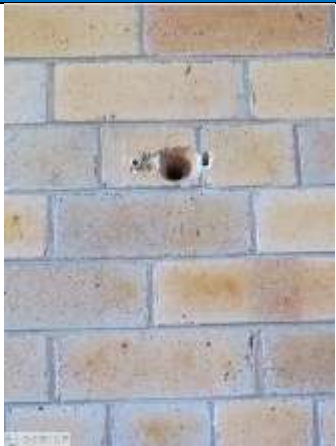
ref	Trade	Description	Image	Status
BZ7	Builder	Wall finish (hole)

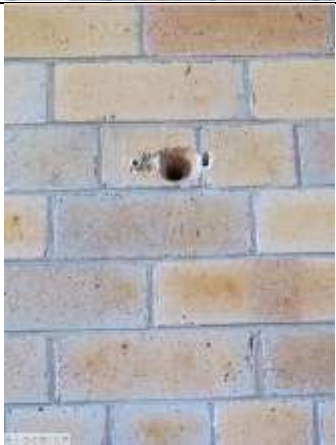
⊗
BZ8	Builder	Wall finish (hole)

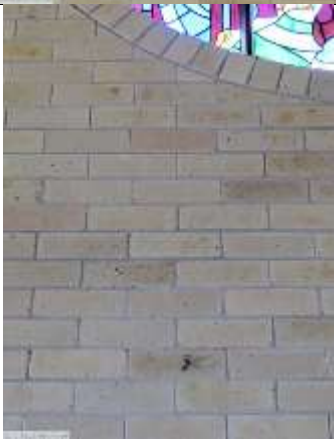
⊗
BZA	Builder	Wall finish

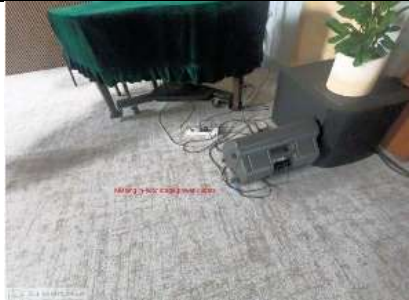
ref	Trade	Description	Image	Status
E1	Elect	Stage missing in floor GPO's

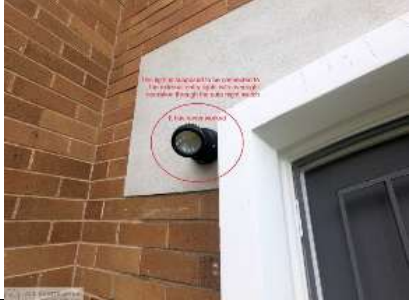
⊗
E2	Elect	NW external flood light never worked

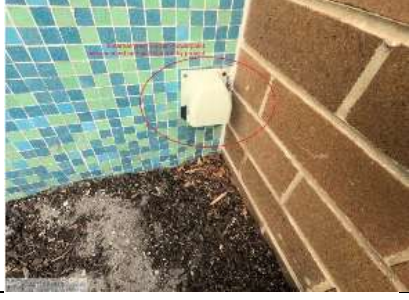
⊗
E3	Elect	West external GPO never worked

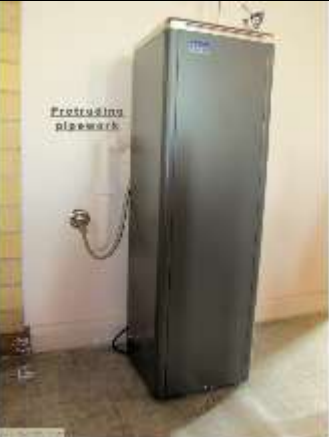
⊗
P4	Plumber	Water bubbler All filtered units must (EPA regulation) be fitted with a backflow prevention device (double check valve or RPZ) between the supply and the filter. Where is this device?

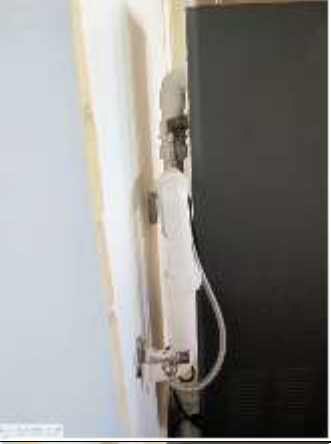
⊗
P6	Plumber	Water bubbler – poor installation and all pipework should have been within and concealed to the vestry

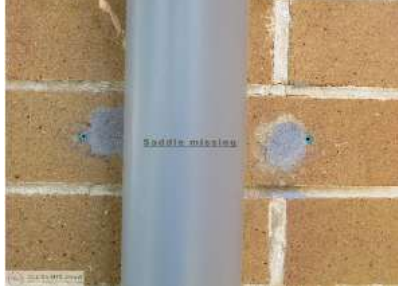
ref	Trade	Description	Image	Status
R1	Roofer	Screws protrude through soffit	  A close-up photograph of a wooden soffit. Several screws are protruding from the surface. A text label 'Protruding Screws' is overlaid on the image.	⊗
R2	Roofer	Downpipe misaligned to waste	  A photograph showing a white downpipe that is misaligned with the gutter. The pipe is positioned over the gutter's edge instead of being centered. A text label 'Downpipe misaligned' is overlaid on the image.	⊗
R3	Roofer	Downpipe saddle missing

A close-up photograph of a white downpipe passing through a brick wall. There is no saddle or flashing visible where the pipe enters the wall. A text label 'Saddle missing' is overlaid on the image.	⊗
R4	Roofer	Flashing Deficient (flashing does not appear to have been cut into the mortar joint, simply butted up and silicone applied) This isn't appropriate flashing.	  A photograph of a white metal flashing installed on a brick wall. The flashing is simply butted up against the wall without being cut into the mortar joints. A text label 'Poor Flashing' is overlaid on the image.	⊗

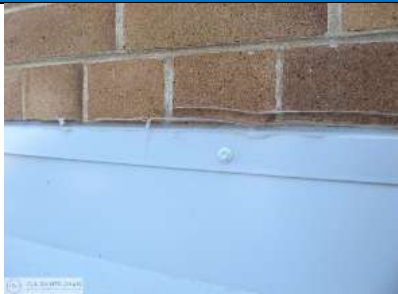
ref	Trade	Description	Image	Status
R6	Roofer	Flashing silicon seal (is flashing cut into mortar?)

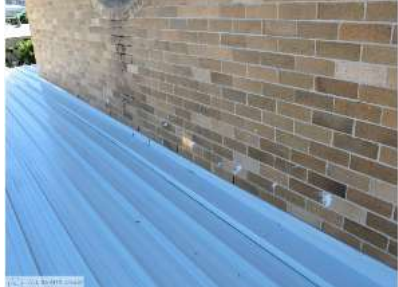
⊗
R7	Roofer	Flashing silicon seal (is flashing cut into mortar?)

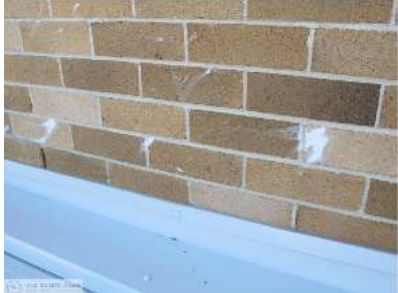
⊗
R8	Roofer	Flashing silicon seal (is flashing cut into mortar?) and deficient cleanup

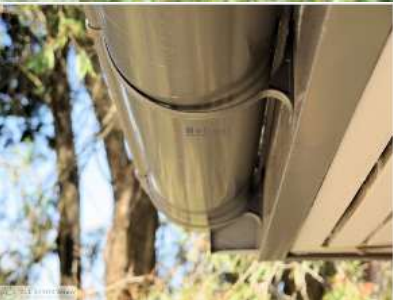
ref	Trade	Description	Image	Status
RA	Roofer	Gutter not set	 	⊗
RB	Roofer	Gutter not set

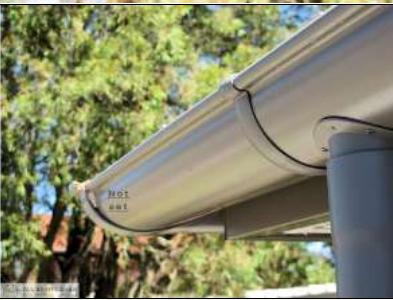
⊗
RC	Roofer	Gutter not set

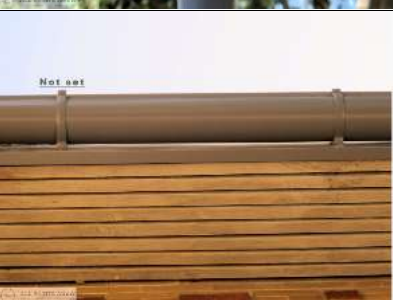
⊗
RD	Roofer	Gutter not set and spout not fully sealed	 	⊗
RE	Roofer	Gutter not set

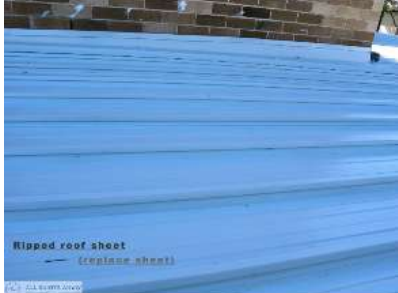
ref	Trade	Description	Image	Status
RG	Roofer	Gutter lengths butted not secured	  A close-up photograph of a gutter joint. The gutter is a light grey color. The joint is butted, and there is a visible gap between the two pieces. A metal strap is visible, but it does not appear to be properly secured or sealed. The text "Butted not sealed joint" is overlaid on the image.	⊗
RH	Roofer	Ripped roof sheet (requires replace sheet)	  A photograph of a blue corrugated metal roof sheet. There is a significant tear or rip in the sheet, exposing the underlying structure. The text "Ripped roof sheet" is overlaid on the image.	⊗
RJ	Roofer	Ripped roof sheet

A photograph of a blue corrugated metal roof sheet. There is a large, irregular hole or tear in the sheet. The text "Ripped roof sheet (replace sheet)" is overlaid on the image.	⊗
RJA	Roofer	Ripped roof sheet	  A photograph of a blue corrugated metal roof sheet. There is a large, irregular hole or tear in the sheet. The text "Ripped roof sheet (replace sheet)" is overlaid on the image.	⊗

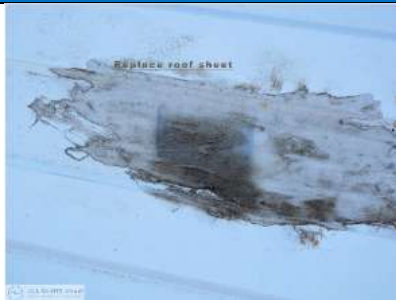
ref	Trade	Description	Image	Status
RL	Roofer	Roof hole

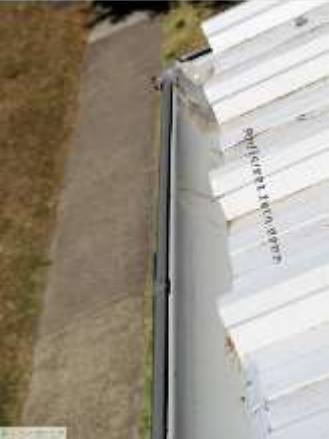
ref	Trade	Description	Image	Status
RN	Roofer	Roof sheet deficient turn down Rust marks where roofer has dropped pop rivet spikes (all over – many waste spikes and a number of screws collected.

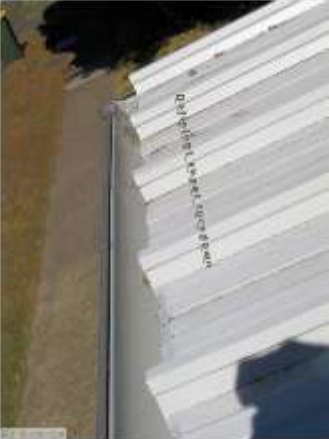
⊗
RP	Roofer	Roof sheet deficient turn down

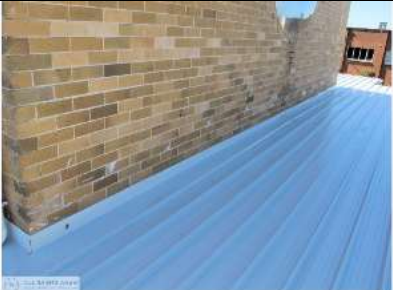
⊗
RQ	Roofer	Flashing deficient

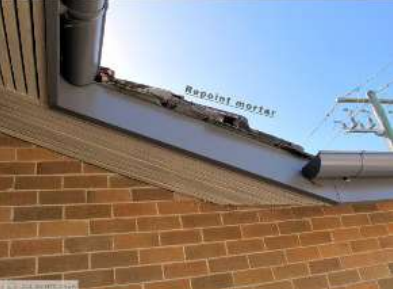
⊗
RS	Roofer	Roof tiles edge unsealed need mortar pointing

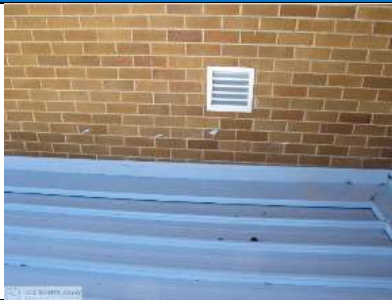
ref	Trade	Description	Image	Status
RT	Roofer	Flashing deficient (note toilet exhaust)

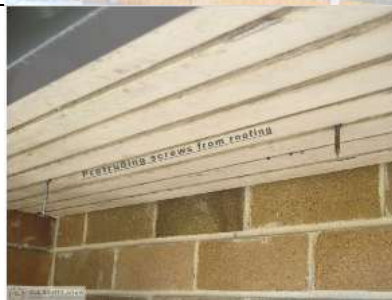
⊗
RW	Roofer	Protruding screws through soffit

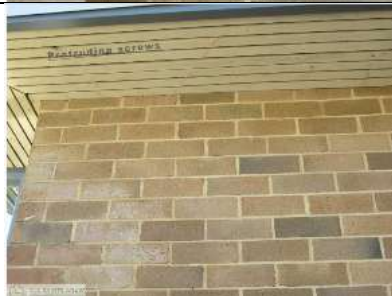
⊗
RX	Roofer	Protruding screws through soffit

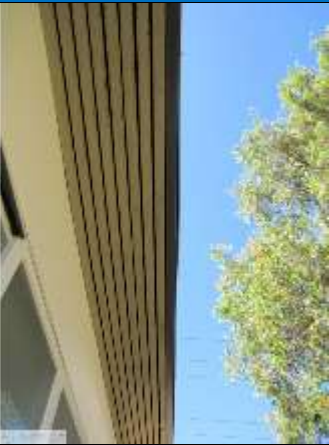
ref	Trade	Description	Image	Status
RY	Roofer	Protruding screws through soffit

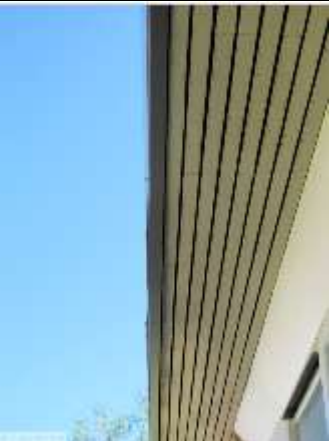
⊗
RZ	Roofer	Protruding screws through soffit
