ALL SAINTS ANeW

Recorded Issues inclusive of non-compliances and defects
associated with the Refurbishment Project for

All Saints ANeW Anglican Church building

Building Works Renovations Defects as at 6th March 2026

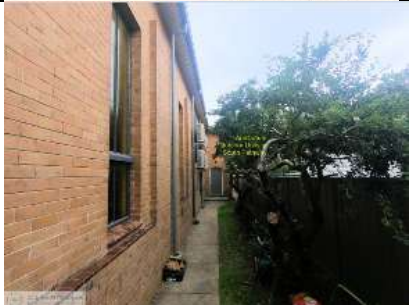
⊗
A4	A/C	South West passage view Auditorium outdoor units - comply

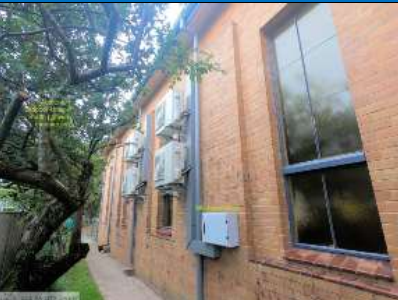
ref	Trade	Description	Image	Status
A5	A/C	South passage view Auditorium outdoor units and mechanical DB - comply

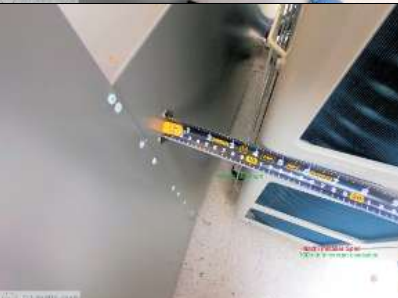
⊗
AA	A/C	Unit at minimum clearance of 100mm

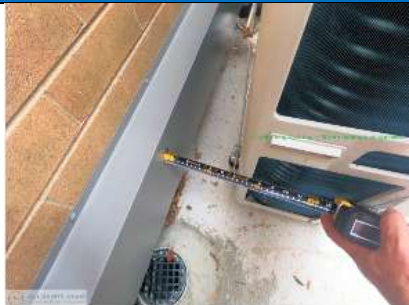
ref	Trade	Description	Image	Status
AB	A/C	Unit exceeds minimum clearance

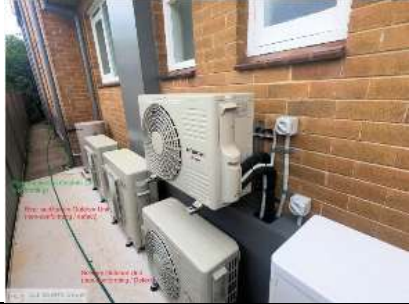
✓
AC	A/C	Vestry and Servery outdoor units

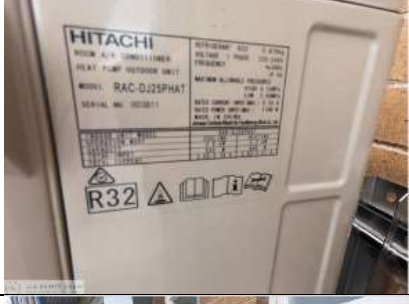
✗
AD	A/C	Vestry outdoor unit dataplate

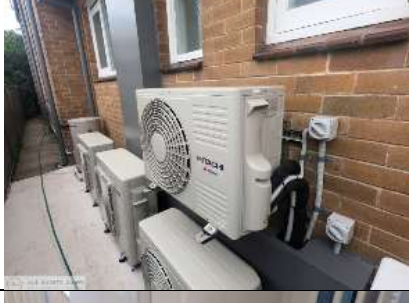
info
AE	A/C	Servery outdoor unit (may be servery)

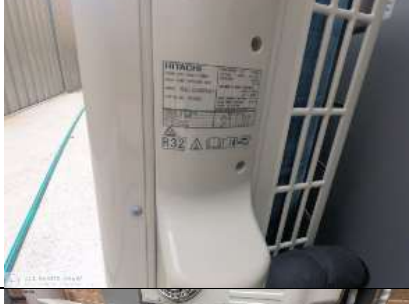
✗
AF	A/C	Servery outdoor unit dataplate

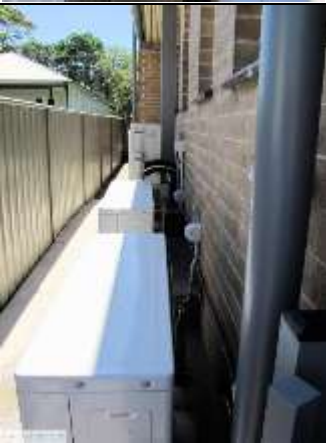
⊗
AJ	A/C	Cassette units ok

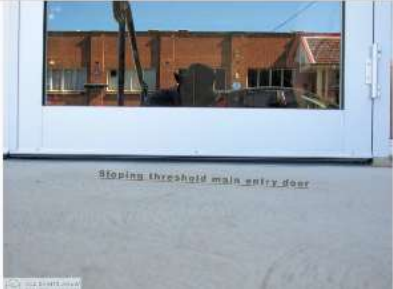
⊗
BD	Builder	Main entry threshold not level and No debris seal for bottom plate

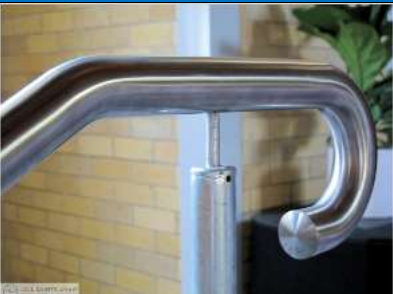
ref	Trade	Description	Image	Status
BT	Builder	Handrail ramp to stage turndown and stub post interface

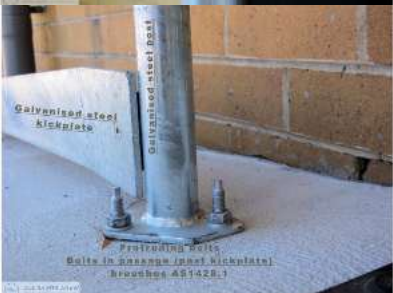
⊗
BU	Builder	Proud bolts protrude into ramp – non conforming to AS1428.1

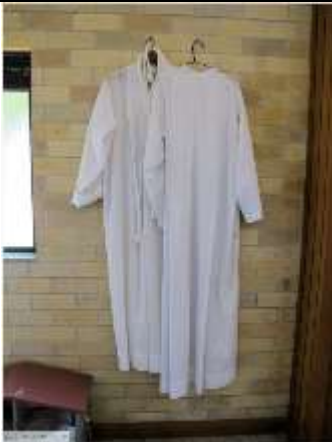
⊗
BZ4	Builder	<p>Vestry had no hanging rail</p> <p>Maintenance has since installed a hanging rail into the vestry cupboard.</p>

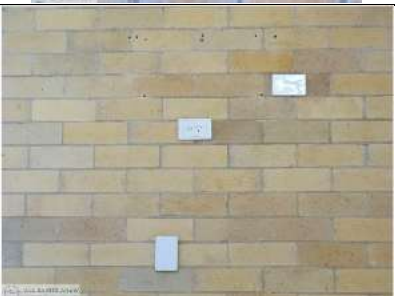
⊗
BZ9	Builder	Wall finish

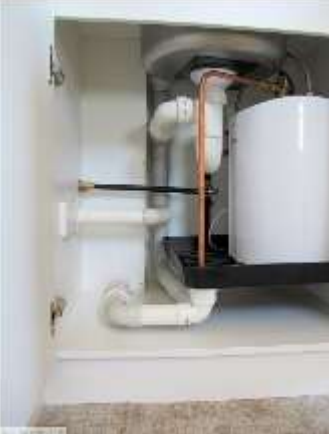
?
P2	Plumber	Under Zip boiling water unit

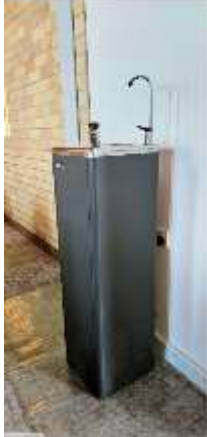
info
P3	Plumber	Water bubbler Not f spout turned (and it can easily do so) it is directly above and could flood power outlet.

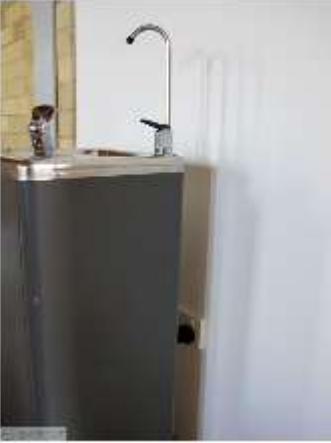
ref	Trade	Description	Image	Status
P5	Plumber	Water bubbler

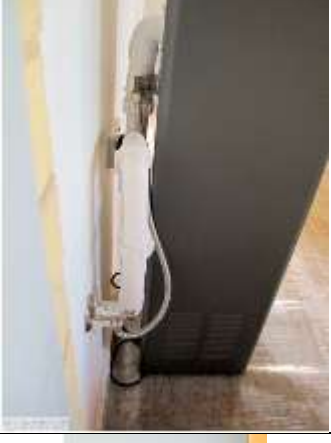
⊗
P7	Plumber	Water bubbler

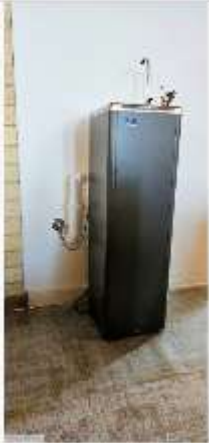
ref	Trade	Description	Image	Status
P9	Plumber	Water bubbler pipes

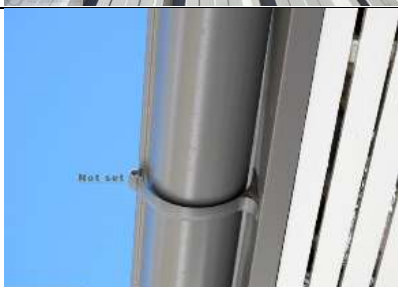
⊗
R9	Roofer	Gutter not set

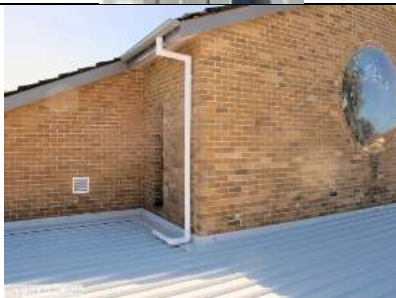
RM	Roofer	Roof SE corner Unpainted downpipe

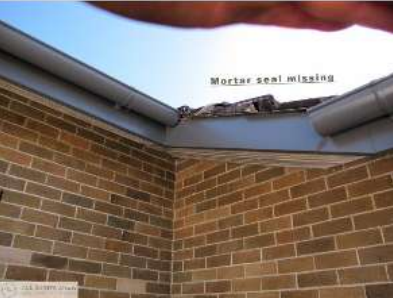
⊗
RR	Roofer	Roof tiles edge unsealed need mortar pointing

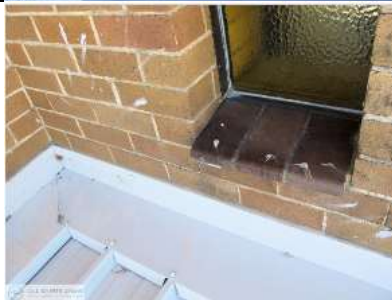
⊗
RU	Roofer	Above vestry

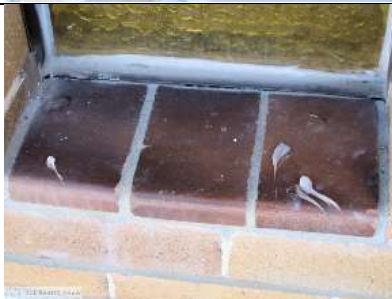
⊗
RV	Roofer	Window sill external above vestry
